THE DETERIORATION OF TIMBER MATERIAL IN TRADITIONAL MALAY HOUSE IN MALACCA

Nur Nabihah Shafiin[1)] **& Shahrul Yani Said**[1),2)*]

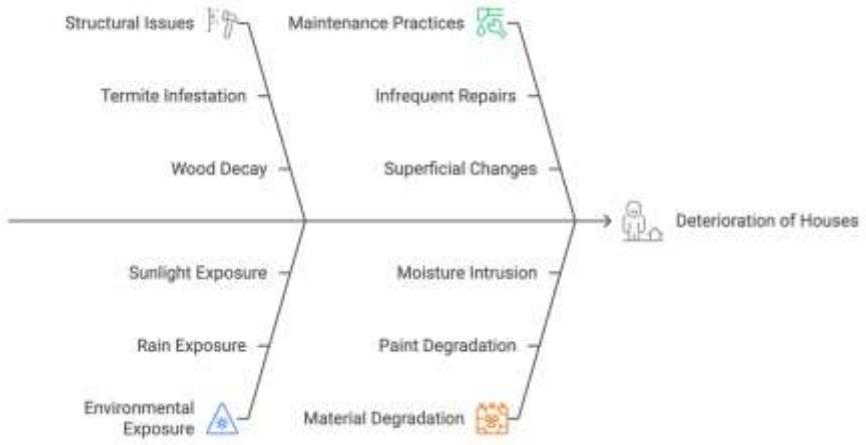
Figure 15 describe causes led to decay of the three houses. The deterioration of Malay houses results from a complex interplay of structural vulnerabilities, environmental influences, and maintenance practices. Structural issues, such as the intrinsic weaknesses in the building's framework, can be exacerbated by biological attacks like termite infestation and natural processes like wood decay. These biological factors weaken the structural integrity of the house over time, making it more susceptible to damages.

Figure 15: Causes of defects that lead to deterioration of the three houses

Environmental exposures—such as prolonged sunlight, rain, and general weather conditions—accelerate material degradation by causing surface wear, paint erosion, and moisture ingress. Sunlight exposure can cause cracking and fading of surface finishes, while rain and humidity facilitate moisture penetration, leading to rot and fungal growth. These environmental stresses, in combination with biological deterioration and a lack of proper maintenance, significantly contribute to the progressive damage of the house.

Maintenance practices play a crucial role in either mitigating or accelerating deterioration. Infrequent repairs, superficial surface treatments, and neglect in addressing early signs of damage allow issues to compound. Moisture intrusion, if not promptly managed, leads to further decay of timber and structural components, while superficial changes that do not address the underlying issues result in ongoing material degradation. Poor maintenance and repair practices thus significantly influence the rate at which these traditional houses deteriorate.
